Manhole Inspection Summary

Manhole # S33SS_032MH

Insp Date: **4/19/07 9:34 AM**

Location Address: **2640 LOVEGROVE ST**

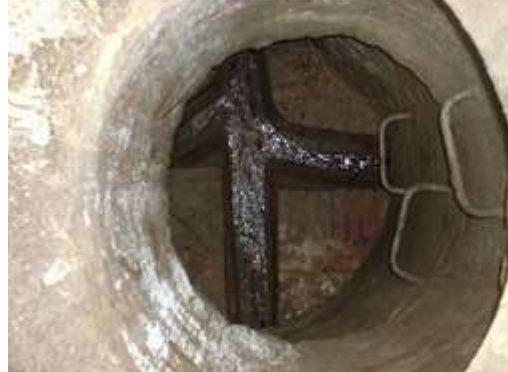
Top View

Corroded and missing steps. Barrel root intrusion and infiltration. Bench debris.

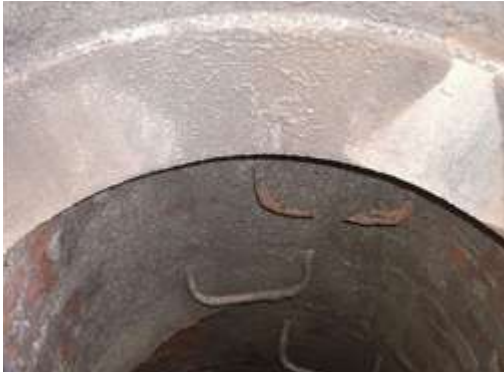
Defect

Frame leaks. Frame offset. Adjustment and Barrel infiltration.

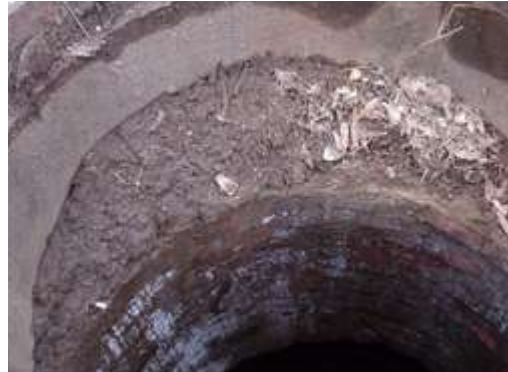
Defect

Frame leaks. Frame offset. Adjustment infiltration.

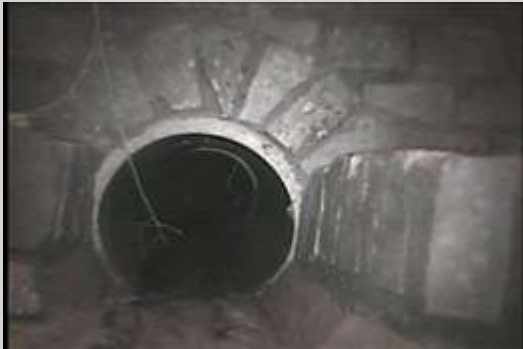
8 in. Circular Gravity Sewer Pipe Out @ 12 O'Clock

Pipe Material: **Clay** ☐ Pipe Lined

Invert Depth: **8.00** (ft.) Flow Characteristics: **Fast**

Infiltration: **None** Pipe Seal Cond: **Unknown**

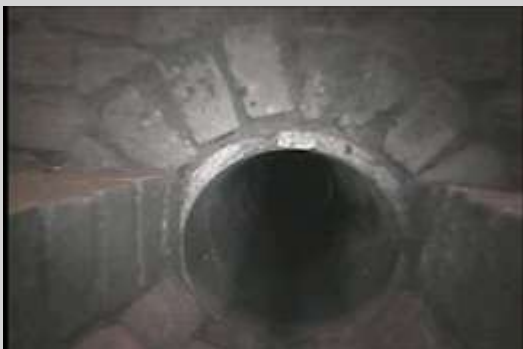
8 in. Circular Gravity Sewer Pipe In @ 3 O'Clock

Pipe Material: **Clay** ☐ Pipe Lined

Invert Depth: **7.85** (ft.) Flow Characteristics: **Slow**

Infiltration: **None** Pipe Seal Cond: **Unknown**

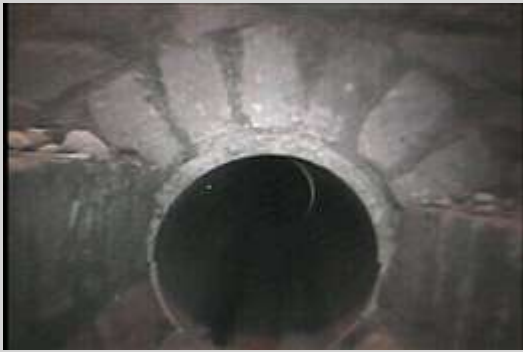
Pipe In @ 6 O'Clock

Pipe Material: **Clay** ☐ Pipe Lined

Invert Depth: **7.93** (ft.) Flow Characteristics: **Fast**

Infiltration: **None** Pipe Seal Cond: **Unknown**

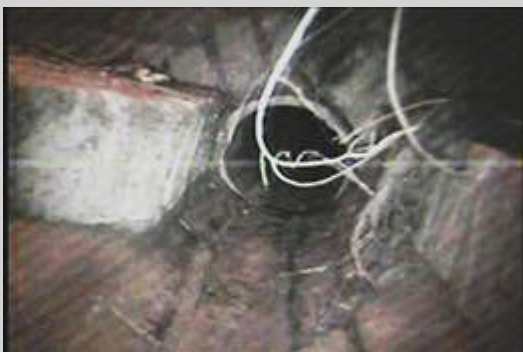
Pipe In @ 8 O'Clock

Pipe Material: **Clay** ☐ Pipe Lined

Invert Depth: **7.89** (ft.) Flow Characteristics: **Slow**

Infiltration: **None** Pipe Seal Cond: **Unknown**
